P-REP-10120-10044

2018 PICKERING NUCLEAR GROUNDWATER MONITORING PROGRAM RESULTS

2019-03-26

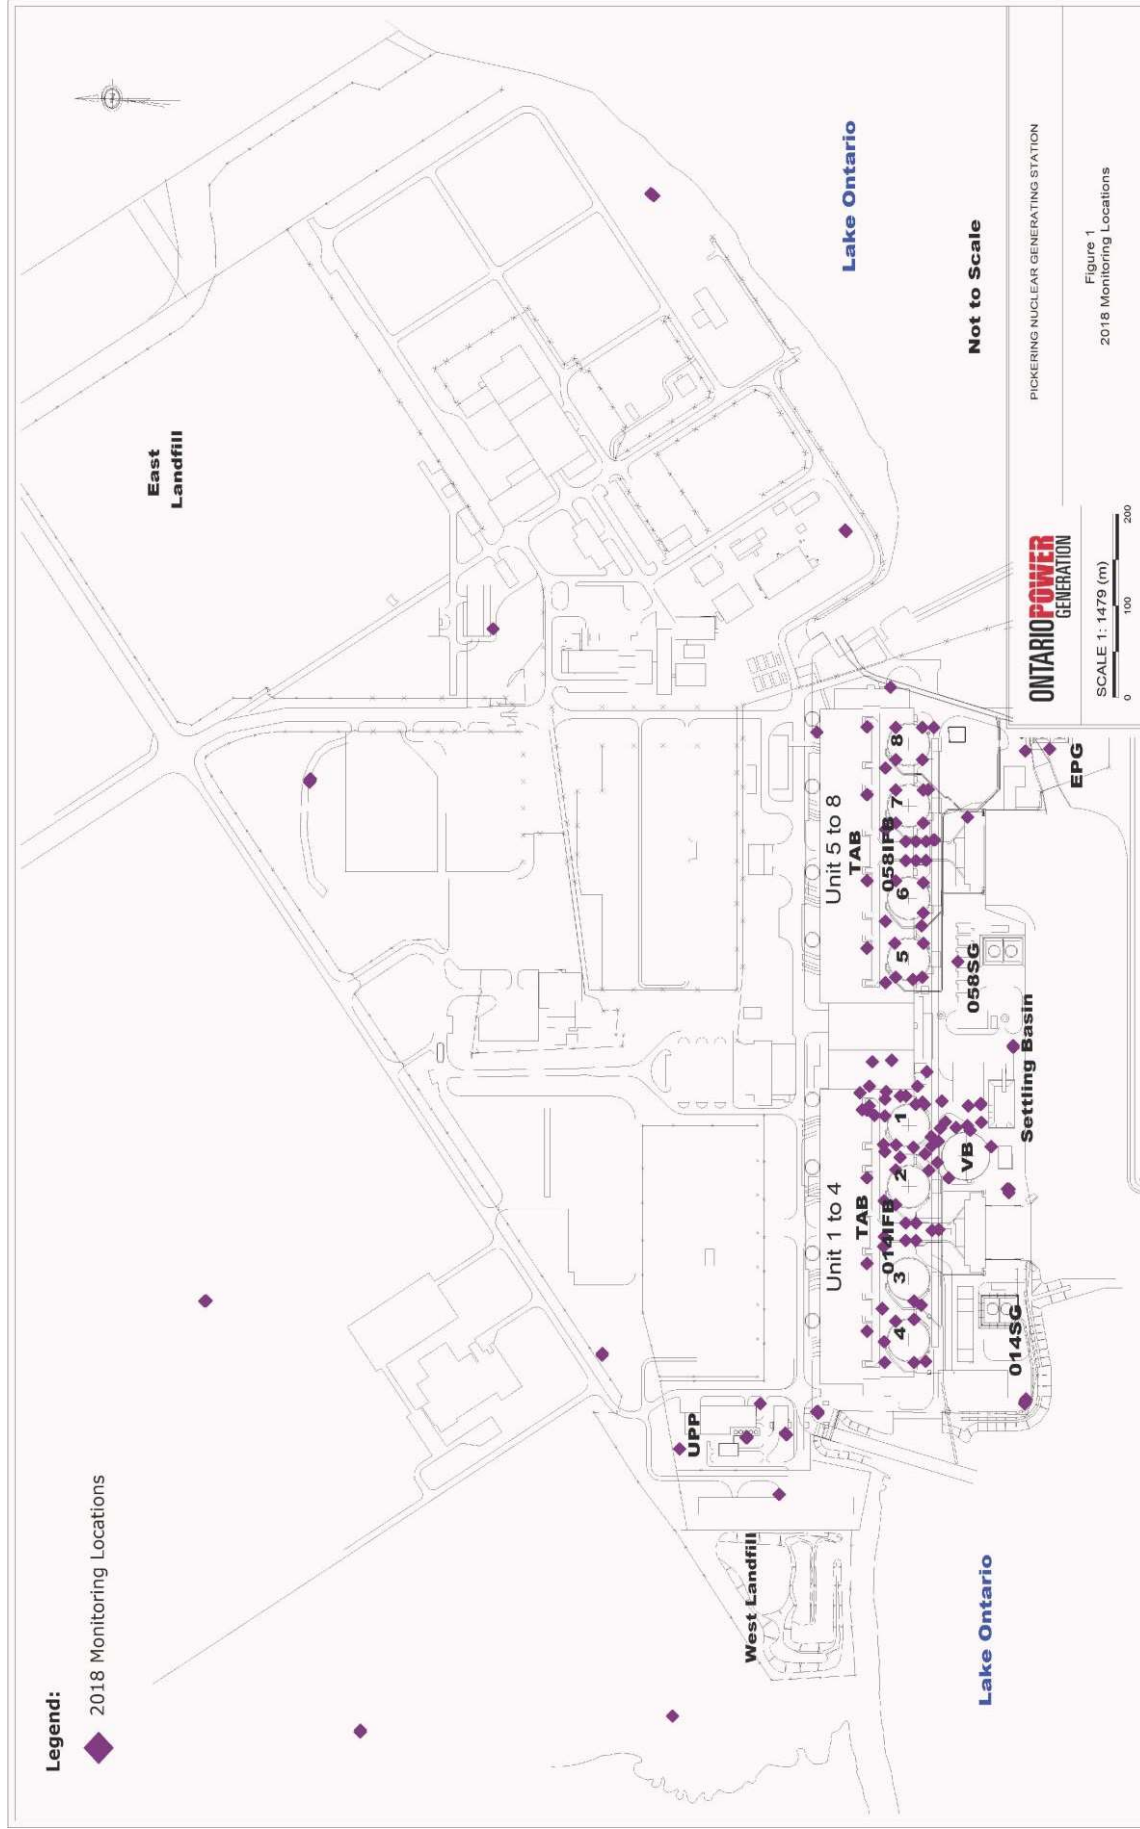
In 2018, as per the SAP, groundwater samples were collected from various locations, including monitoring wells, foundation drains, sumps, and groundtubes (146 sampling locations in total). Figure 1 (Page 9 of this report) shows these locations, and it can be seen that the majority of data was collected from locations near the operating reactors.

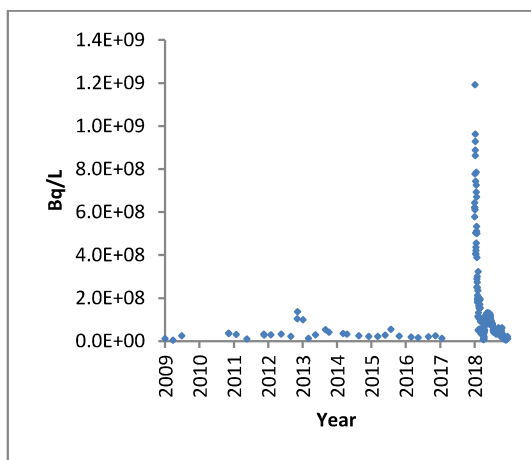
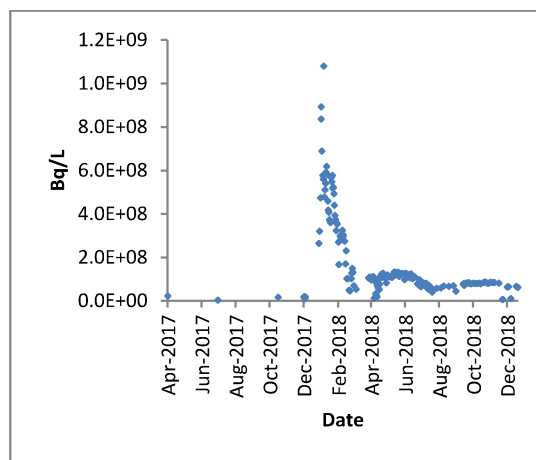
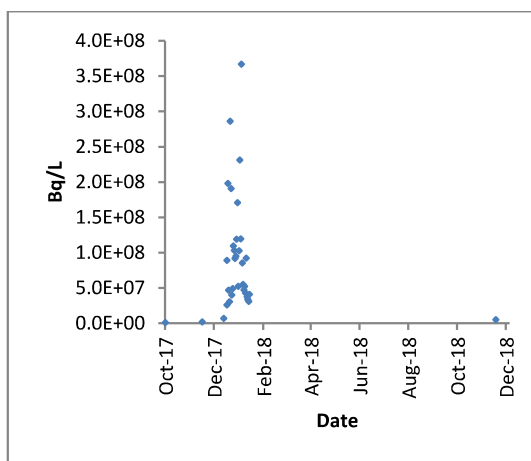
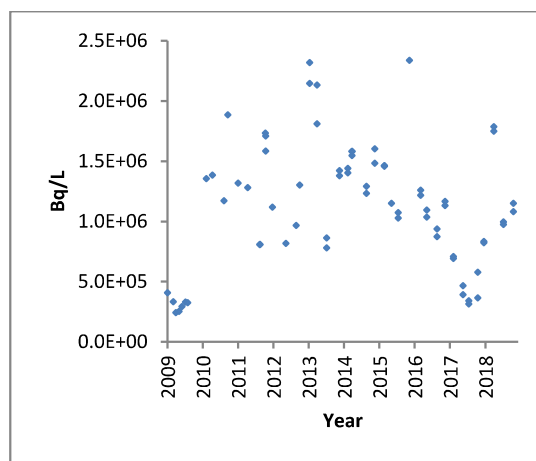
In 2018, an adverse condition was identified in the Unit 1 area groundwater, which was attributed to a component leaking inside the moderator purification room. Corrective actions were undertaken and have been successful in addressing the source as supported by the data discussion below in Section 3.2.2.1.

In 2018, the highest concentration of tritium in groundwater was found at the Unit 1 RB groundtube location, U1-RBFD-1. This was identified in 2018 Q1. Groundtubes are rudimentary wells that were installed when the station was built and perform similarly to monitoring wells. Essentially, these sample locations are steel tubes that are perforated along its side-wall close to the bottom of the tube. The perforations allow groundwater to enter the tube. Around the RBs, the groundtubes terminate in the foundation drains encircling the RBs, within the shallow groundwater regime.

Graphs 1 to 4 on the following page illustrate the tritium concentrations over time for the Unit 1 RB foundation drainage groundtubes. In addition, data for the VBRS is also presented. As mentioned in Section 3.1, the VBRS acts as a hydraulic sink, diverting a portion of groundwater in the Unit 1 and 2 areas.

Following the identification of elevated tritium concentrations in the groundtube, the frequency of monitoring at the groundtubes and surrounding monitoring wells was immediately increased. A team was formed to locate the source of the leak and establish a plan for repair. Based on a very extensive and thorough investigation, the elevated tritium in the Unit 1 foundation drains was found to originate from a valve leaking inside the Unit 1 moderator purification room. The valve was subsequently repaired. Deficiencies in the moderator purification room which had allowed a path to groundwater were also identified and successfully repaired. A post maintenance test was performed, which confirmed the effectiveness of the repair. Since the repairs were completed, a significant decrease in tritium concentrations in groundwater has been observed, confirming that there are no on-going leaks. Groundwater monitoring continues in this area.

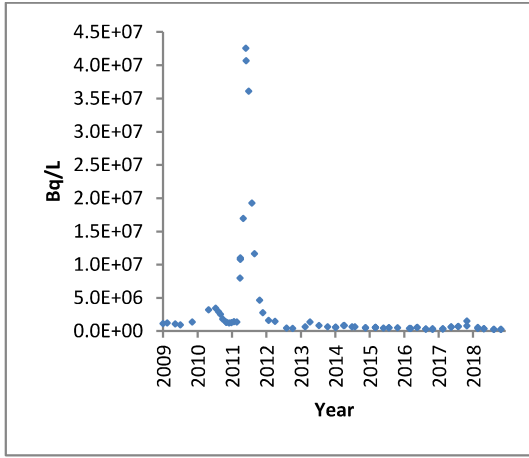
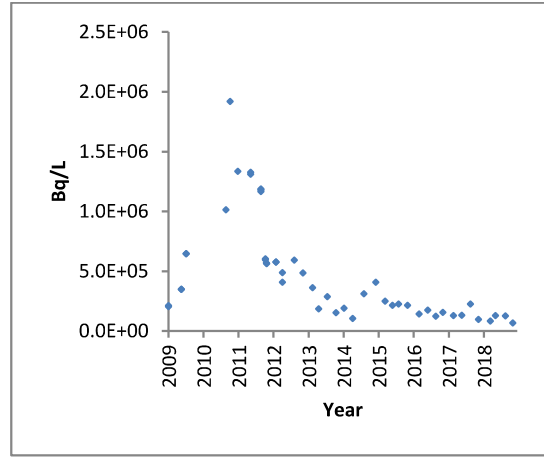
In the Unit 3 and 4 area, the results from the RB groundtubes as well as from the monitoring wells located within the Reactor Auxiliary Bay (RAB) were stable. The concentration at MW-242-25 (which is adjacent to SRST vault sump, MK6) continues to remain low. This indicates that the repairs undertaken at MK6 in 2013 have been effective. The tritium concentration at downgradient monitoring well MW-243-29, also located in the RAB, did not show any significant changes. Graphs 5 and 6 below illustrate the results for these monitoring wells.

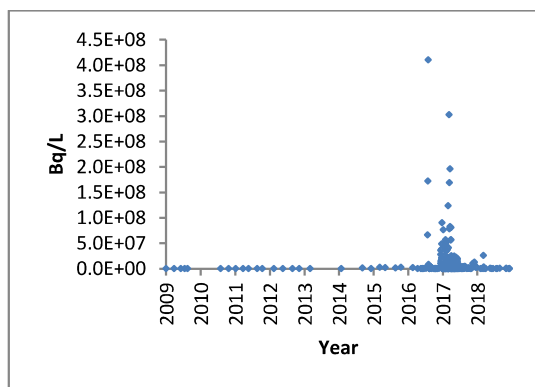
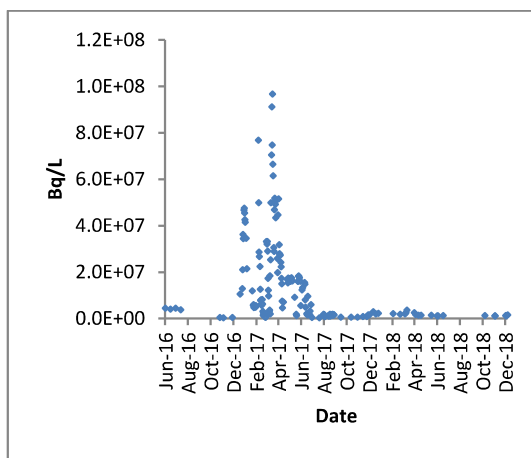
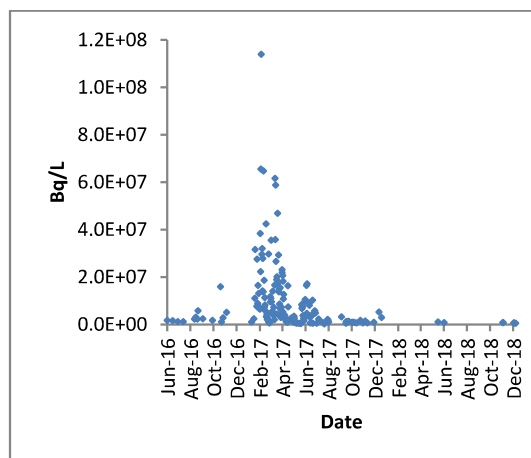
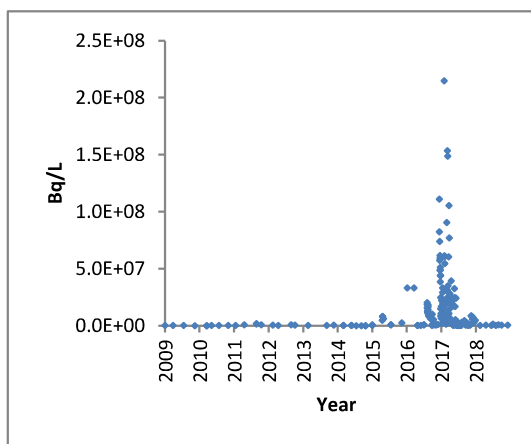
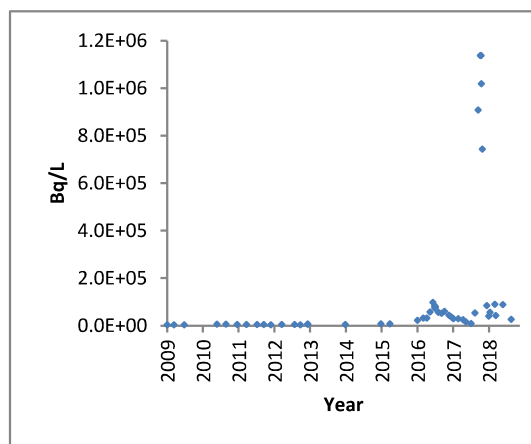
In 2016, an adverse condition was identified in the Unit 5 area due to degraded construction joints in the Unit 5 moderator room floor. A thorough investigation was undertaken, followed by repairs, which have proven to be successful.

The samples collected from the Unit 5 RB area in 2018 indicate that tritium concentrations in groundwater have declined following the repairs completed on the moderator room floor construction joints during the previous year. Graphs 7 to 12 below present the data from the Unit 5 RB foundation drainage groundtubes (RBU5-GT-1 to RBU5-GT-4), the U5 MK26 sump, and monitoring well MW-267-17. Groundwater monitoring will continue in this area to track the movement of tritium.

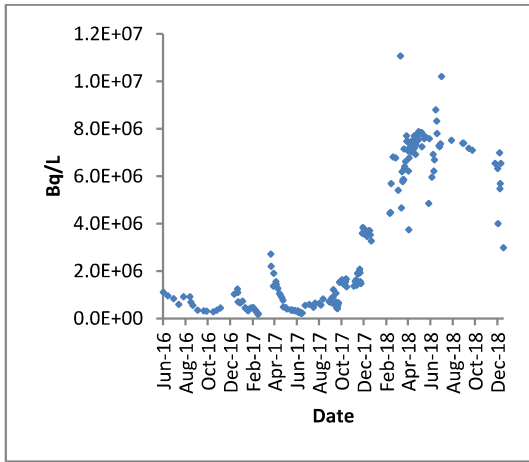
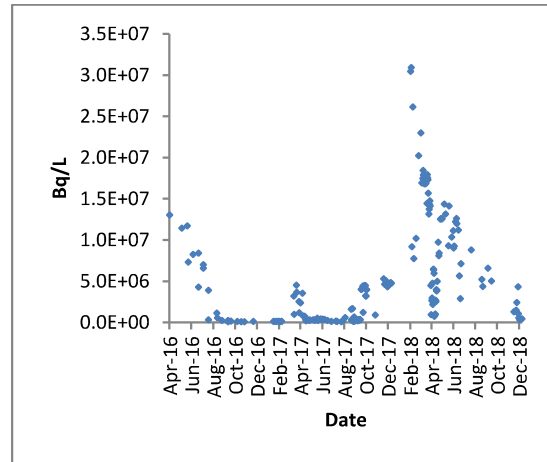
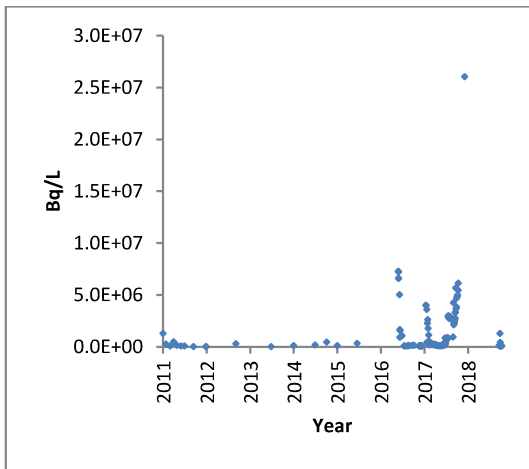
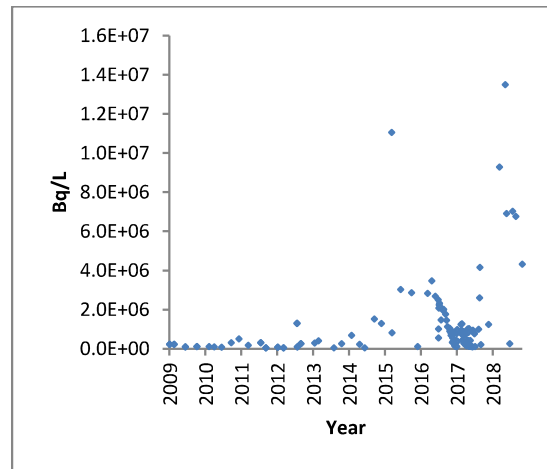
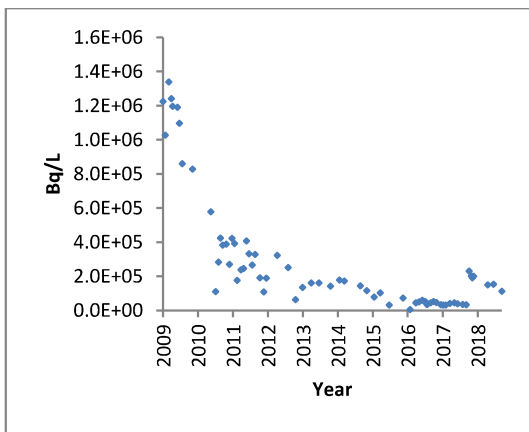
In the Unit 6 area, a concentration increase was noted in the groundtubes in Q1 2018. Based on the operating experience at Unit 5, the moderator floor construction joints at Unit 6 were inspected and repaired in 2018 during a planned outage. A post-dye test indicated that the repairs were successful. Graphs 13 to 17 on the following page present the data from the Unit 6 RB foundation drainage groundtubes (RBU6-GT-2 to RBU6-GT-4), the U6 MK30 sump, and monitoring well MW-266-19. Throughout the remainder of 2018, the tritium concentrations in the groundtubes fluctuated, but an overall decreasing trend was seen. This area will continue to be monitored.

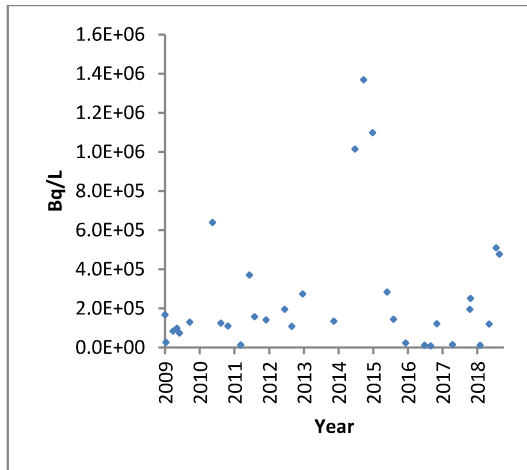
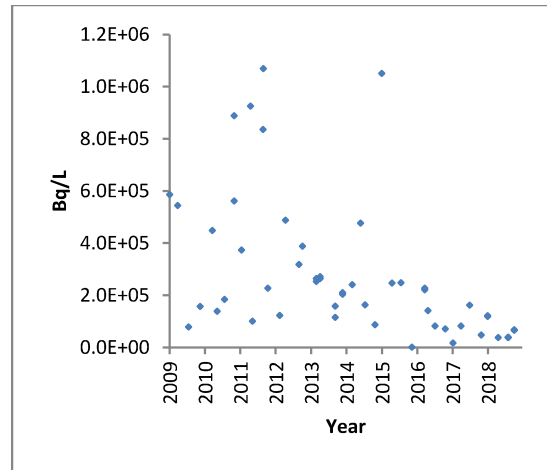
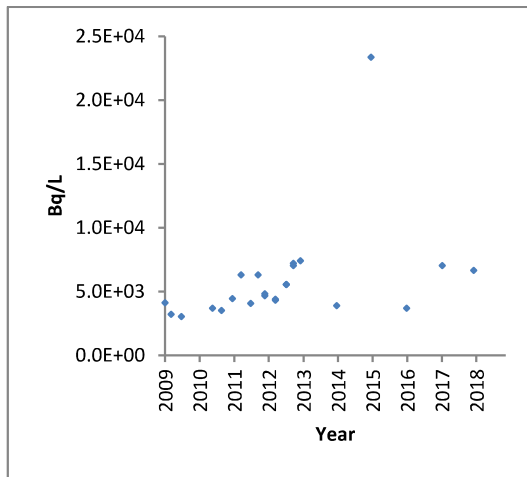
In 2018, there were no emerging issues identified for the Unit 7 area. Graphs 18 to 20 below illustrate the data for RBU7-GT-1, U7 MK36, and MW-265-12.

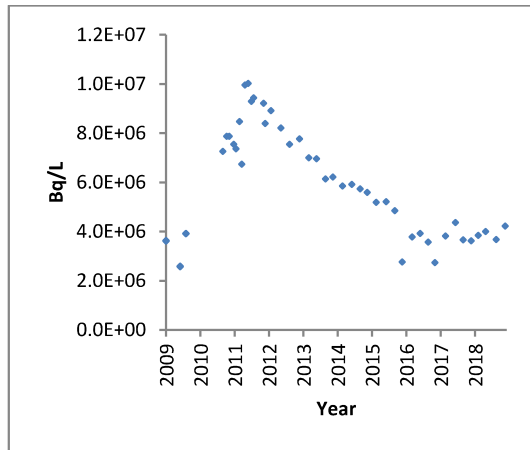
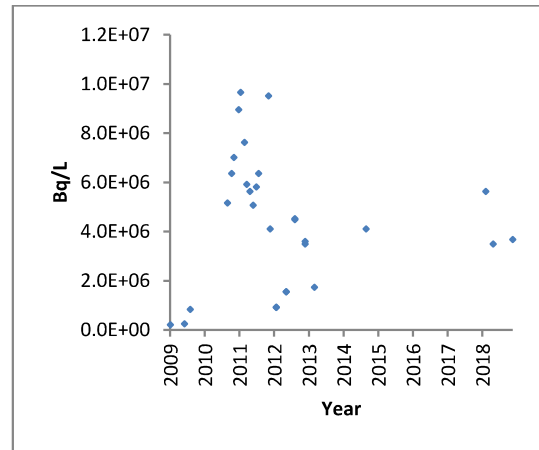
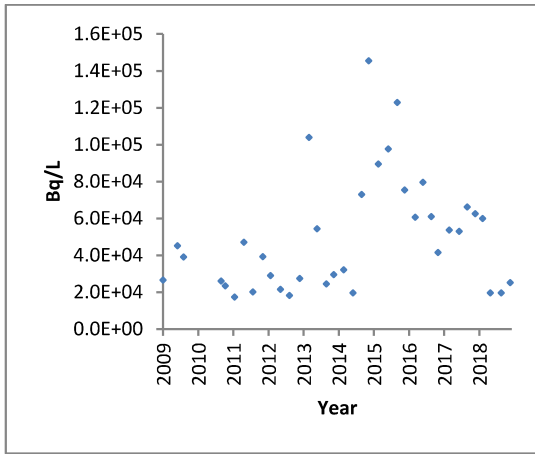
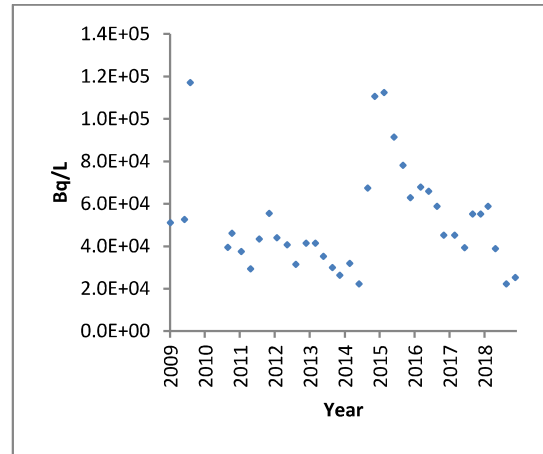
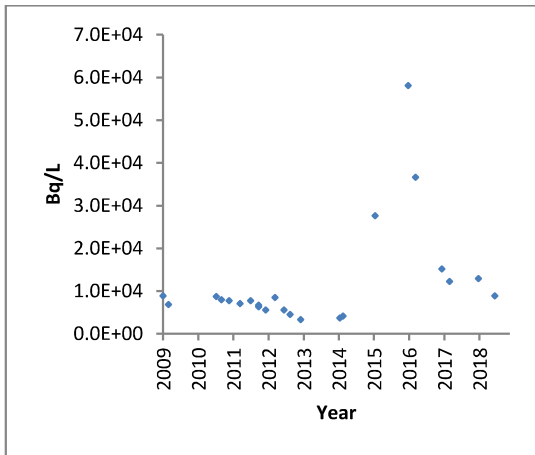
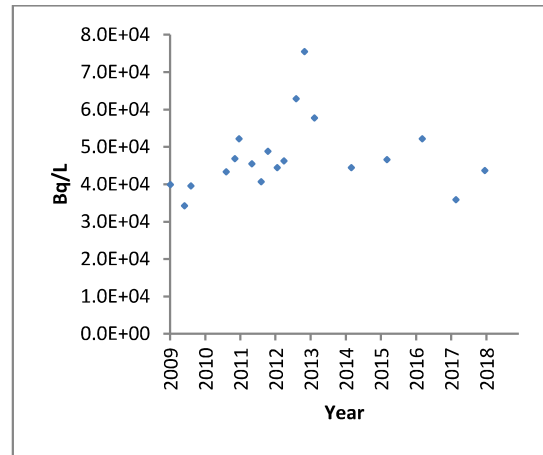
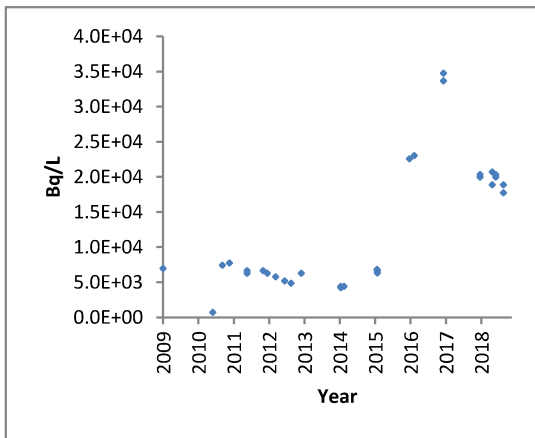
The tritium results from the upgradient monitoring well MW-056-18 and the downgradient monitoring well MW-244-18 did not show any significant changes. Tritium concentrations at upgradient well MW-057-30 had been increasing slowly between 2015 and 2017; however the 2018 results indicate that the concentrations have decreased.

Tritium concentrations over time for the IFB-A groundtubes and monitoring wells are presented in Graphs 24 to 30 below. The results are also presented in Table A-2 (Appendix A) and Figure 3 (Page 16 of this report).

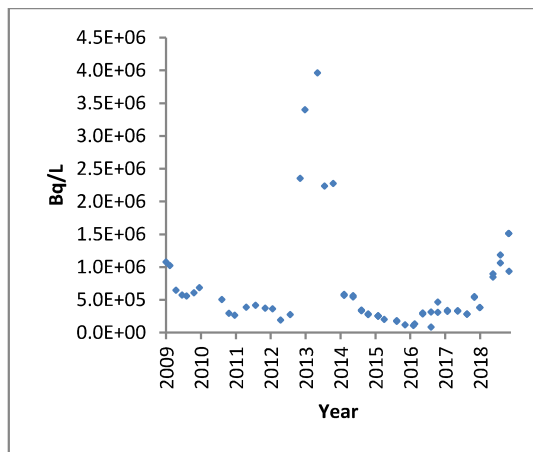
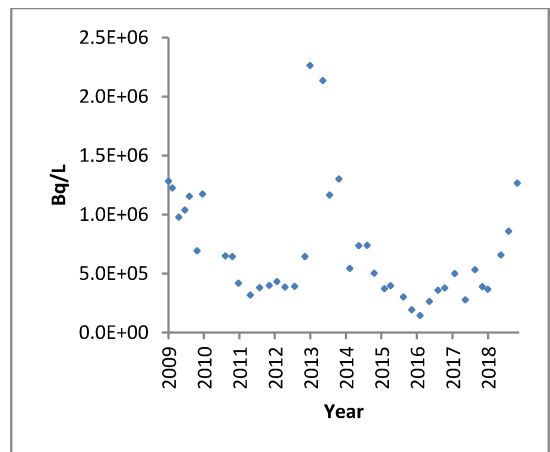
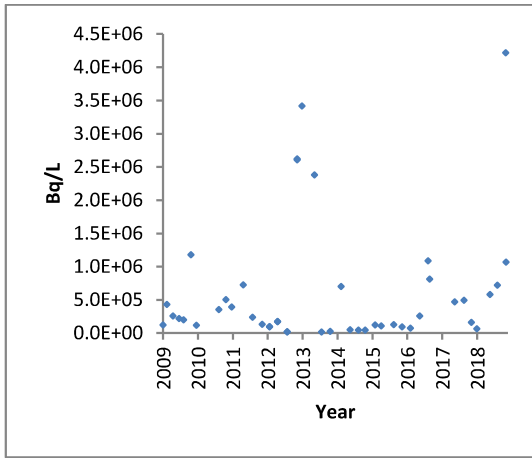
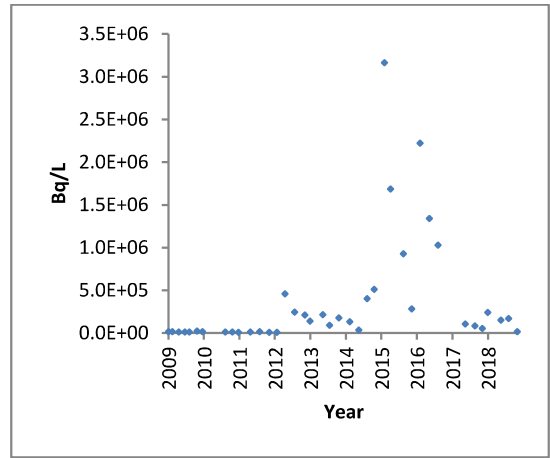
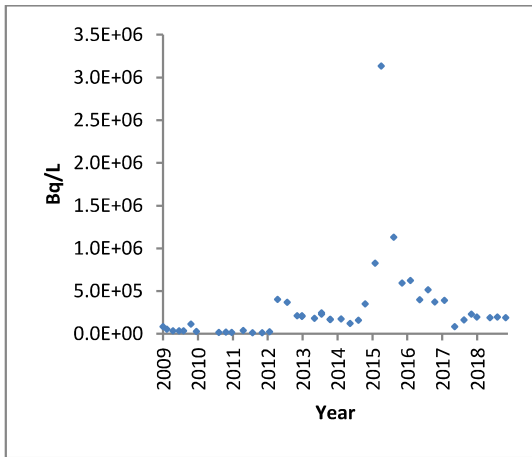
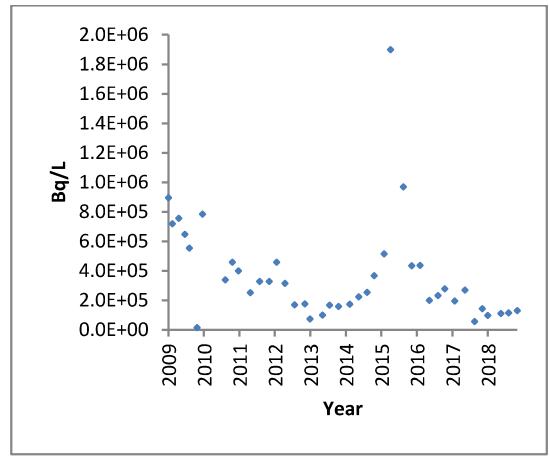
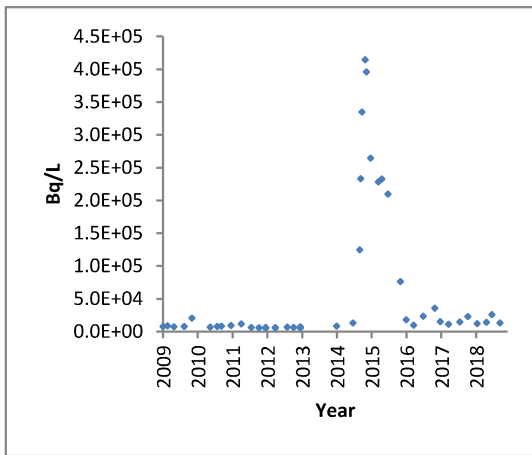
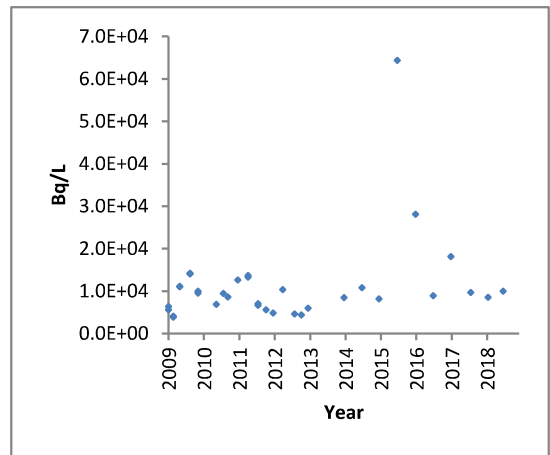
At the IFB-B area (located between Units 6 and 7), increases in tritium concentration were observed in the western groundtubes in 2018, due to the expected movement of tritium in groundwater from the Unit 5 area. The results from the other IFB-B sampling locations were stable. Further discussion is provided below.

In the western groundtubes (IFBB-GT-1B, IFBB-GT-2B, and IFBB-GT-3B), a steady increase in tritium concentrations was observed during the course of the year. This is most likely attributed to the expected movement of tritium in groundwater in a westerly direction from the Unit 5 area. Under Project #13-40703, the repair of discovery cracks in the bay itself were undertaken in April to August of 2018. Prior to this, in 2016 and 2017, the IFB-B sumps were inspected for cracks and subsequently cleaned and repaired. A similar increase in the western IFB groundtubes was seen in 2013 and attributed to the expected movement of groundwater in the area. As mentioned previously, groundwater eventually flows north and is captured by the low-lying TAB sumps.

The two upgradient monitoring wells (MW-171-15 and MW-172-25) continued to show low tritium concentrations.

Tritium concentrations over time for the IFB-B groundtubes and monitoring wells are presented in Graphs 31 to 38 below. The results are also presented in Table A-2 (Appendix A) and Figure 4 (Page 22 of this report).

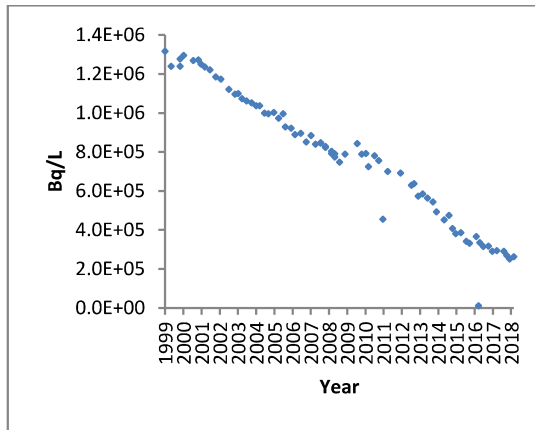
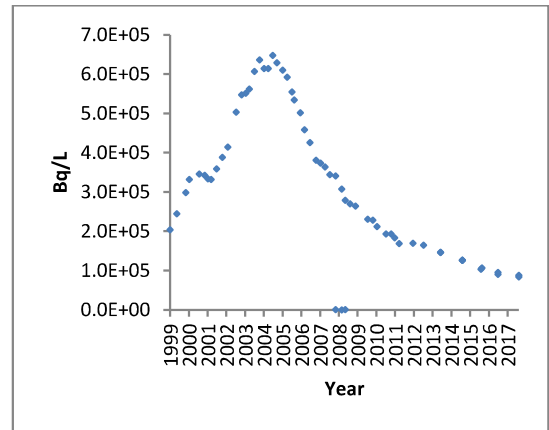
Tritium concentrations at the legacy source area, MW-090-20, continue to decrease as would be expected, given that there is no new source of tritium. In the downgradient monitoring well, MW-076-20, tritium concentrations also continue to decline after a peak seen in 2005. A portion of the outer edge of the UPP tritium plume is directed westwards towards the warehouse due to a preferential groundwater pathway created by a subsurface utility pipe. Monitoring well MW-096-20, located by the warehouse, had shown a generally increasing trend until about 2011; however, recent concentrations have stabilized.

Tritium concentrations over time for the above-mentioned monitoring wells are presented below in Graphs 39 to 41. The results for the locations sampled in the UPP area are presented in Table A-5 (Appendix A) and Figure 5 (Page 28 of this report).
